Re: Insured: Christopher Taylor
Claim No: 33-D493-449
Date of Loss: August 29, 2011
Our File No: 121093

AMENDED AND SUPPLEMENTAL REPORT

Pursuant to your request, McDowell Owens Engineering, Inc. has conducted an electrical investigation and analysis of a fire loss at 190 Cedar Valley Lane in Louisburg, North Carolina that occurred on August 29, 2011. A preliminary report based upon information available at that time was released in August of 2012. Since that time, new information has become available. The following is an amended form of that preliminary report along with a supplement. This amended and supplemental report is released in order to properly reflect the new information. Conclusions and opinions expressed in this report may be further supplemented or amended should additional information become available.

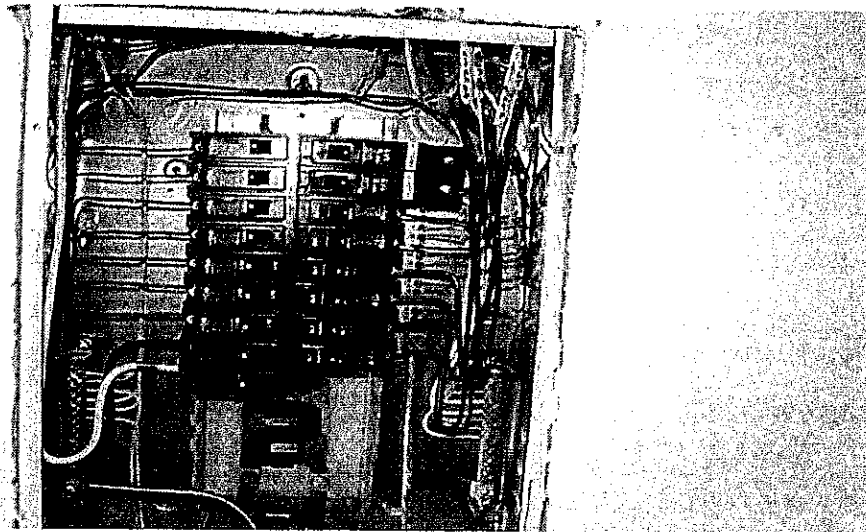
PHOTO 1 - Element Analytical Photo 416

Underground electrical service is provided to the residence via a 200-Amp Cutler-Hammer main breaker panel located on the east exterior wall of the house. Power is distributed from the main panel to two sub-panels inside the house. At the service entrance location, proper system grounding mechanisms were observed to be in place. Photos revealed no evidence of failure or problems with any of the electrical service equipment. Material used in the wiring of the house was standard and installation workmanship of the electrical wiring appeared to be superior. In summary, no issues were observed in or on the electrical system that were in any way related to the cause of the fire.

**Electrical System Workmanship is of Professional Quality
No Evidence Found of any Condition Causally Related to the Fire**

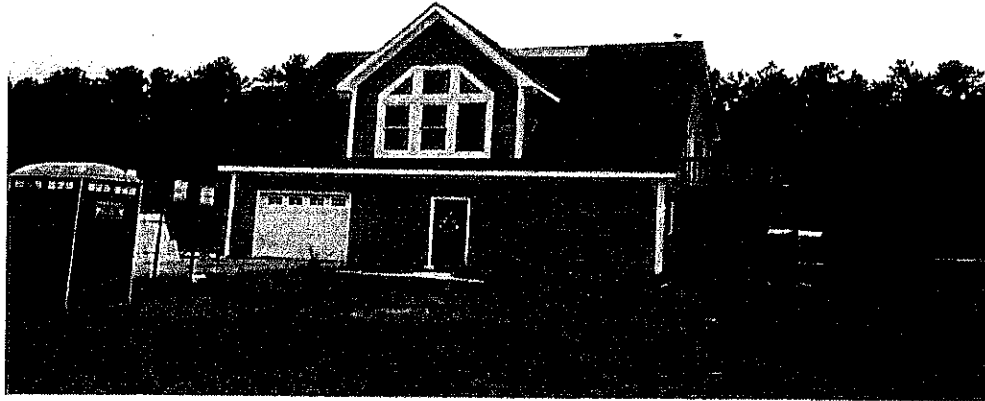
PHOTO 2 - Element Analytical Photo 001
South Side of the House at 190 Cedar Valley Lane
(Shows only a Small Portion of the Tarp on the South Side of the Roof Ridgeline)

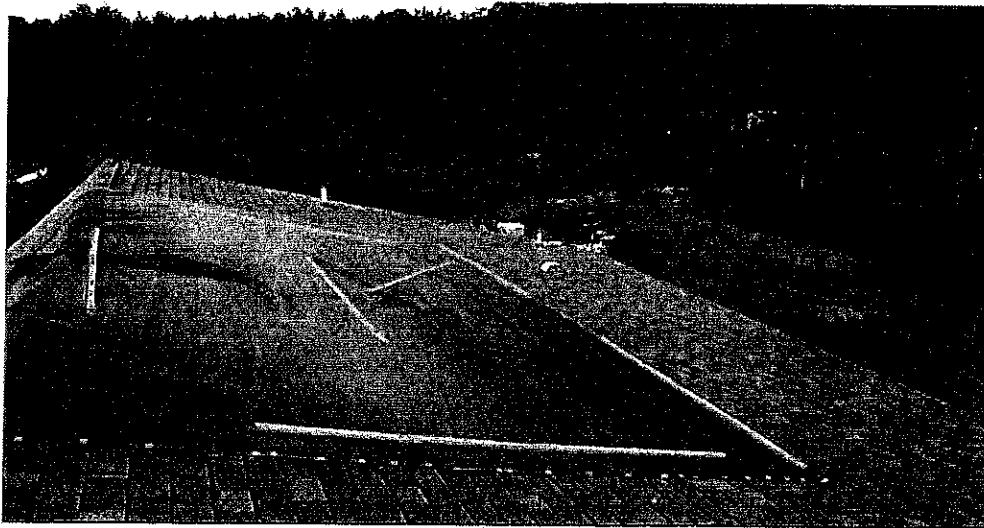
On the exterior of the house, fire damage was observed on the center section of the *north*-facing roof surface and on a small portion *south* of the roof ridgeline. As this was an attic fire, the area that sustained actual burn damage (consumption of material) was primarily under the roof deck and on the rafter assemblies. The main burned area was near the east-to-west center of the roof deck and just *north* of the roof ridgeline (see PHOTO-3). The size of the heavily burned area appeared to be less than 8 feet by 12 feet.

PHOTO 3 - Element Analytical Photo 221
Shows Tarp over the Main Burned Damage on the North-Facing Roof

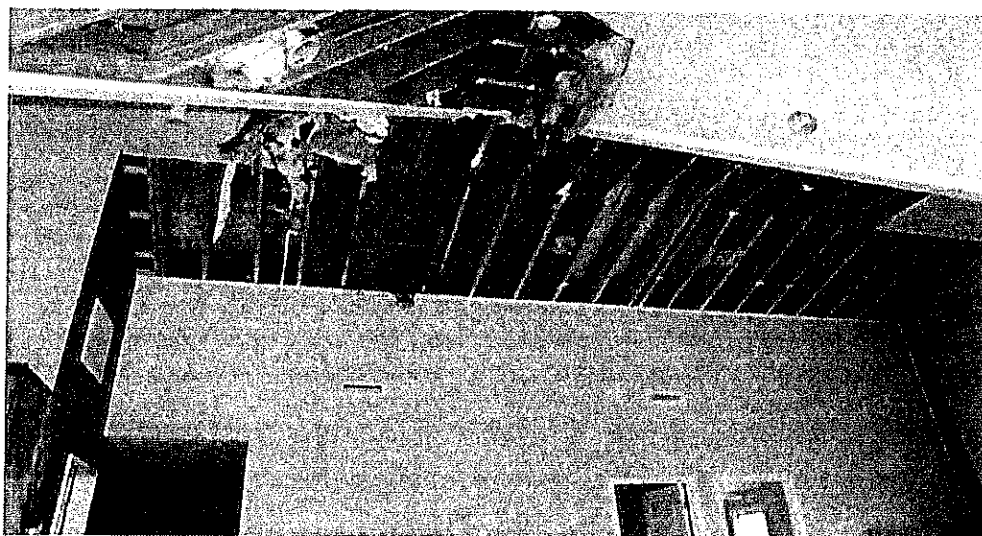
PHOTO 4 - Element Analytical Photo 171

Fire damage in the residence at 190 Cedar Valley Lane was primarily confined to the attic space. The area that sustained actual burn damage (consumption of material) was on and under the roof deck and on the rafter assemblies. The main burned area was near the east-to-west center of the roof and just *north* of the roof ridgeline. The size of the heavily burned area appeared to be less than 8 feet by 12 feet.

**Most Attic Burn Damage Localized at Upper-Center of North Roof Deck
(Note Temporary Sheathing where Burned Radiant Barrier Sheathing was Removed)**

Burn damage patterns on vertically oriented surfaces can be useful in identifying exact area of origin as flame tends to spread upward and outward (see NFPA 921, Chapter 6). Photos show the lowest burn damage is approximately 8 to 10 feet north of the roof ridgeline. The burn pattern spreads up and out from there and continues all the way up to the ridgeline of the roof. Information provided by Mr. McGraw supports a finding that the fire point of origin was in this lower portion of the burn area.

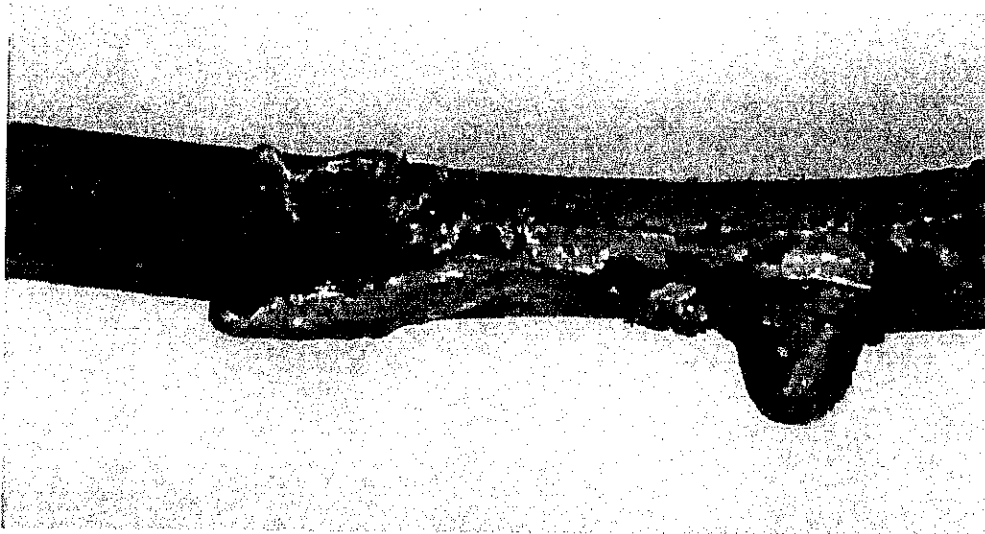
PHOTO 5

During a joint examination of the burn damaged area, conductors from two branch circuits were recovered and retained as evidence. One of the circuits recovered consisted of a section of 14-3 non-metal shield cable (commonly called Romex) and a section of 14-2 Romex. These were identified as Element Analytical Evidence Items #5 and #6 and were reported to have been the only conductors in or near the origin area that were considered as possible causes on the fire. McDowell Owens was able to examine these cables on two occasions. The first occasion was at the McDowell Owens facility in Kingwood, Texas. The second occasion was during a joint and destructive examination at the Goodson Engineering facility in Denton, Texas. During these examinations, McDowell Owens determined that neither of these cables had been causally involved in the ignition of this fire for the following reasons. The 14-2 cable contained no evidence of localized over-heating or electrical activity; therefore, this cable could not have been the cause of the fire. The 14-3 cable did show signs of electrical activity, but in an unusual pattern. The ground wire (and only the ground wire) had evidence of electrical arcing in two locations. The physical appearance of the arcing evidence was consistent with that observed as a result of "arcing through charred insulation"; however, there were no corresponding arc marks on any of the other three wires in the cable. This means that the arc marks on the ground wire could not have been a result of some pre-fire failure of this cable that resulted in arcing between wires of the cable. Since the only other electrical conductor and possible source of current was the aluminum on the radiant barrier material, it must be considered highly likely that the current causing the arcs on the ground wire came from that

aluminum sheet. The fact that there are two separate arc marks further supports this explanation. The current that was available on the aluminum sheet during the lightning strike would fully explain all conditions observed on these wires. Finally, the fact that the arc marks observed on the ground wire (regardless of the source of the current) were found outside of the origin area tells us that the arcing event was not the cause of the fire (see Photo 2 from Rob McGraw's supplemental report).

Shows Arcing on the Ground Wire of the 14-3 NM Electrical Cable

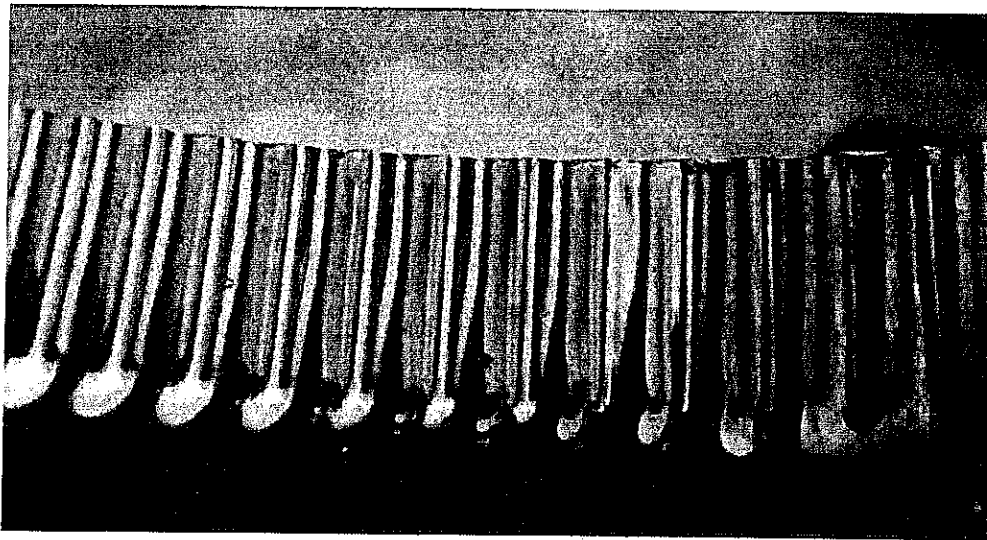
PHOTO 6 - Element Analytical Photo 372

Photographs of the fireplace chimney cap clearly show evidence of a lightning strike. Careful examination of photos revealed that the current entered the cap over a span of several inches and created numerous small points of metal melting.

Shows the Lightning Strike Points on the Chimney Cap

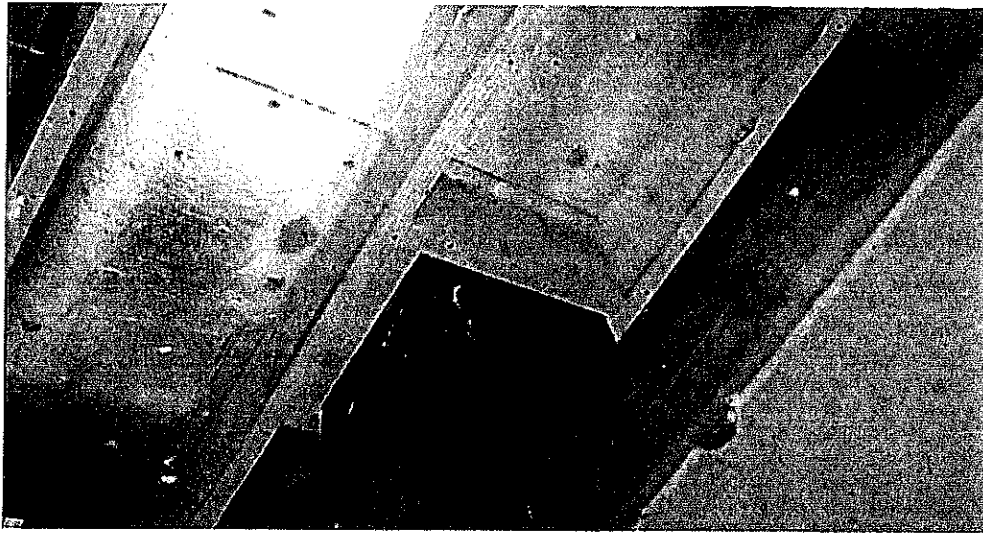
PHOTO 7 - Element Analytical Photo 325

Photos of the radiant barrier foil directly below the chimney pipe flashing show evidence of a large amount of high-voltage electrical current flowing from the chimney flashing through roofing nails to the radiant barrier foil directly below. This evidence establishes that the radiant barrier foil was in fact energized by the lightning from the strike on the chimney cap.

High Current Electrical Burning Around Nails Penetrating Through Chimney Flashing

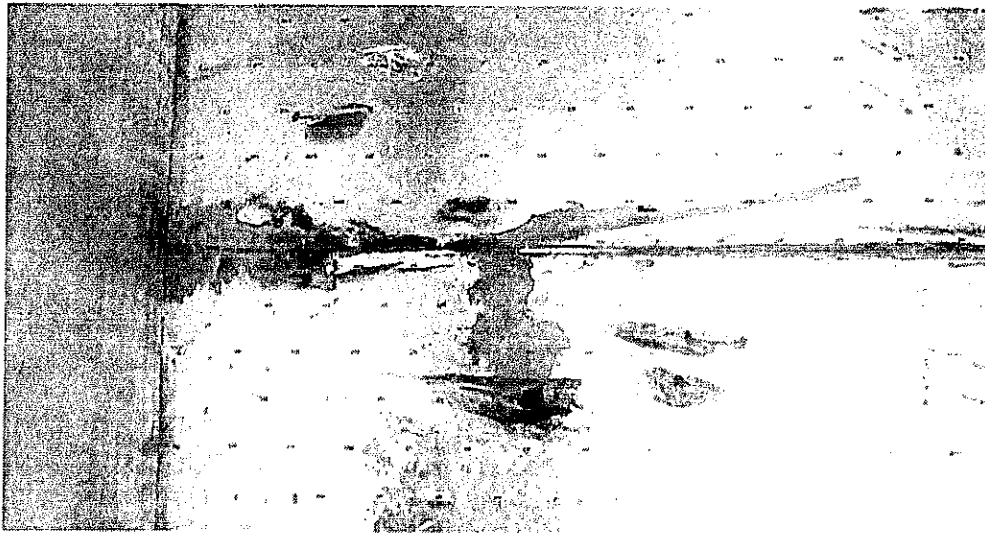
PHOTO 9 - Element Analytical Photo 316

Clear Evidence of Electrical Arcing and Burning at Locations Between Roof Deck Sheathing Sheets Adjacent to the Fire Origin Area

Photos (such as PHOTO 9) show conclusive evidence of arcing at the joints between radiant barrier sheets along the path between the fireplace chimney and the dryer vent. Only one photo is shown above; however, the same pattern existed in many different locations along the current path. The localized blackening and soot deposits show that flames existed at this location.

Of course, the easily consumed radiant barrier material that had been in the middle of the origin area and that initially burned and ignited other materials was no longer available after the fire since, by definition, "it burned". However, photos (such as PHOTO 9 above) clearly show that portions of the material immediately adjacent to the origin area had experienced burning with flame as a result of being electrically energized. We can be completely certain that the radiant barrier material in the origin area was also electrically energized. Therefore, we are certain that material in the origin area would have experienced burning with flame just as the locations immediately adjacent did. Finally, since no other possible source of ignition heat was identified in the origin area, we can be certain that the burning radiant barrier material provided the heat of ignition.

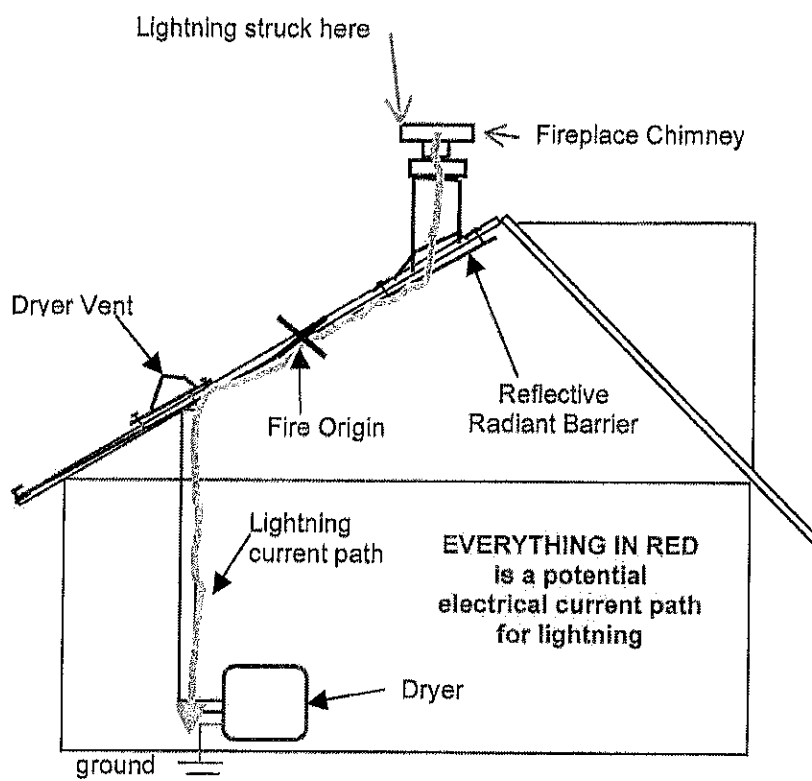
**DIAGRAM 1 - Side View of the House
Lightning Current Path on Radiant Barrier to Ground**

DIAGRAM 1 illustrates the roof's electrical environment present in the structure with the roof sheathing having radiant barrier glued to the underside. **Both the fireplace chimney and the dryer vent were electrically connected to the radiant barrier through nails.**

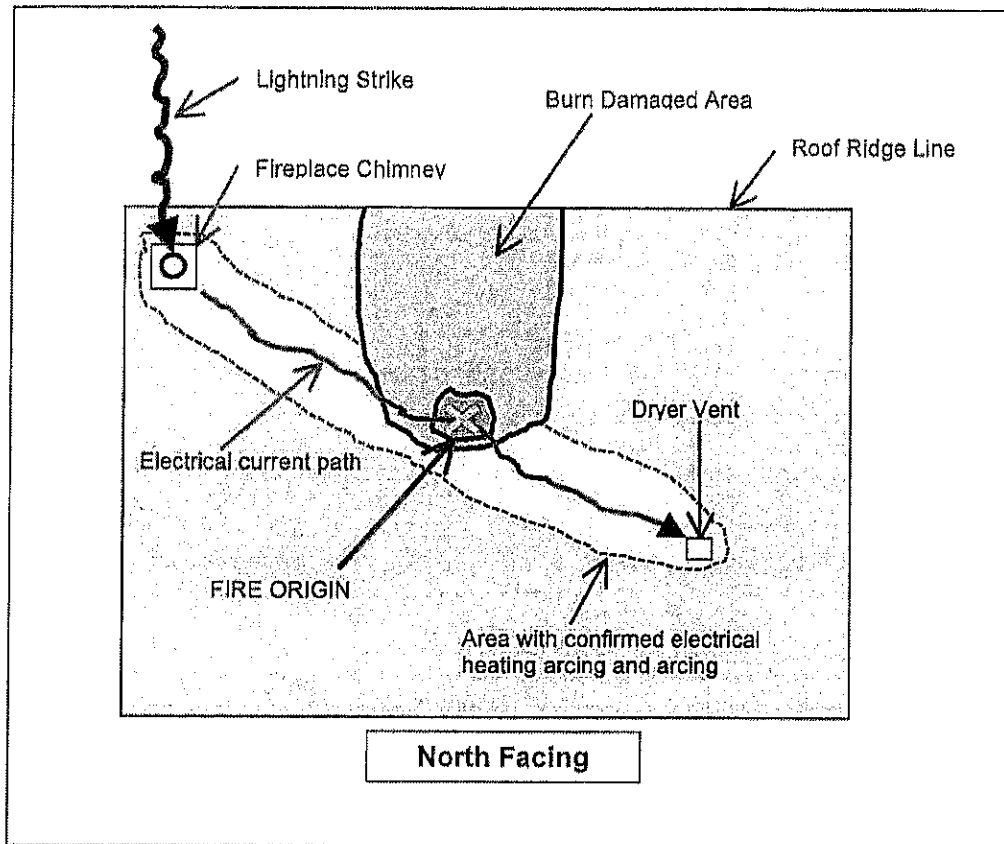
As the lightning current travelled from the strike point on the fireplace chimney to the ground connection through the dryer, it passed directly through the fire origin area. The path of the lightning is recorded by the arcing and burning at the joints between roof sheathing sheets along the path (see PHOTO 9 above). In the bottom paragraph on Page 3 of 10 of his report, Mr. Scardino acknowledges that on the attic side (bottom) of the RBS material, there were areas that exhibited "localized heat effects". The clearly visible "localized black soot" deposits seen in photos leave no doubt that combustion occurred in some of those locations and that the "heat effects" included combustion (burning). These patches of arcing and burning were observed in many locations along a general path between the chimney where the lightning strike occurred and the dryer vent pipe where the lightning current found a robust path to ground.

DIAGRAM 2 - Top View of North Roof
Lightning Current Path on Radiant Barrier Directly Through Fire Origin Area
